# TRAPS AND PITFALLS RELOADED

## Stefan Jagieniak

## ABSTRACT

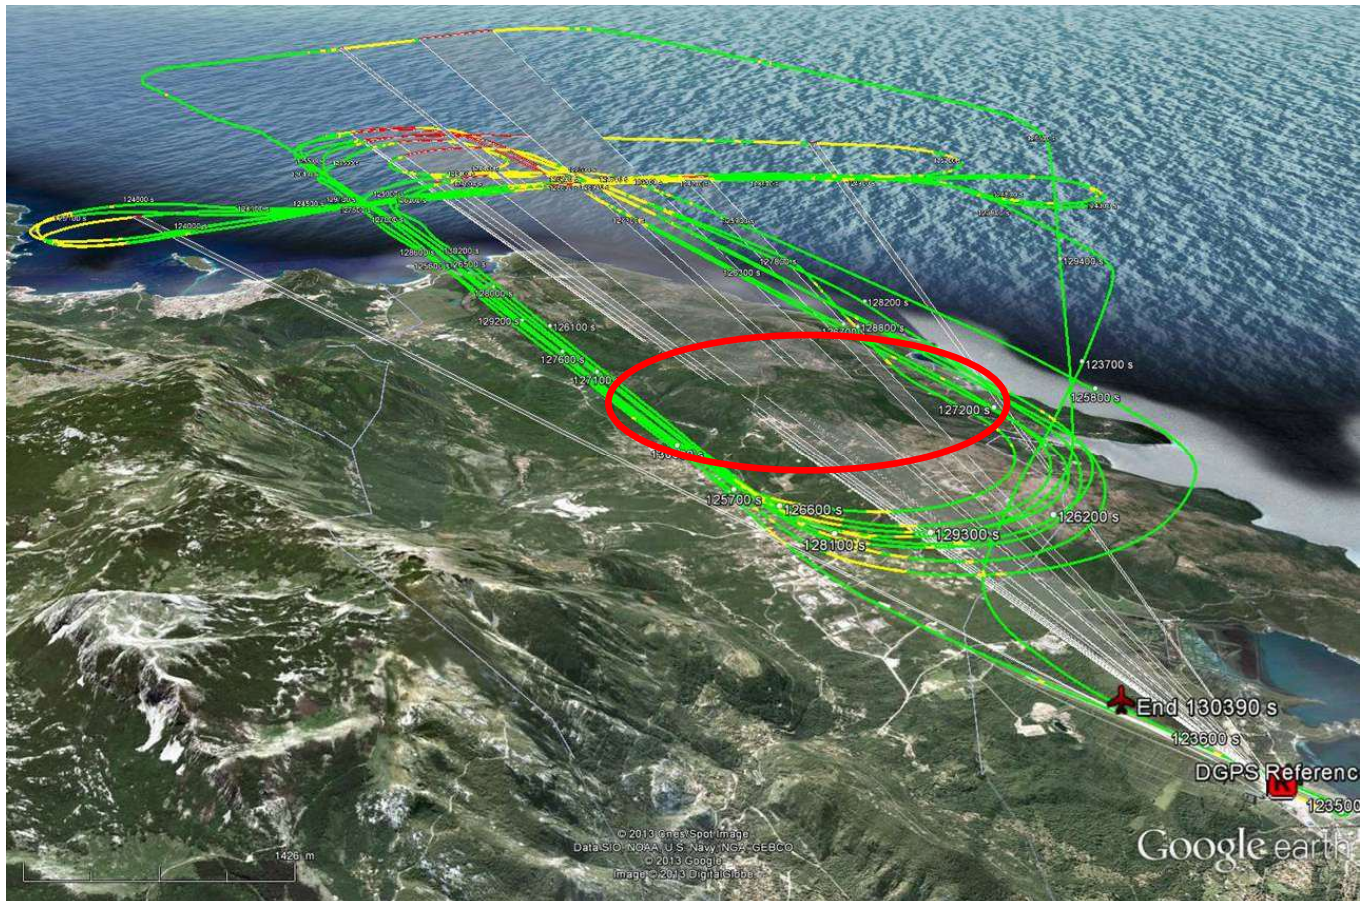
**Figure 1: DGPS Status during an ILS Inspection**

Figure 1 shows the PDGPS status during an ILS commissioning. The color code indicates the GPS quality. The operator was not satisfied with the availability and provided the data for analysis.

Red areas show telemetry interruptions. At 20 NM distance, a height of 2000 ft gives an elevation angle of only  $0.9^\circ$ . Any obstacle like a building, a hill, a mountain will prevent a line-of-sight connection. This is necessary for full integrity and accuracy information. It is important to keep in mind that even such low obstacles at  $0.9^\circ$  have to be avoided when selecting the ground location of the DGPS telemetry uplink antenna. Satellite-based DGPS like SBAS or TerraStar overcomes this issue, but may have drawbacks concerning license cost and proven integrity.

The red ellipse highlights the mountain peaks interrupting the line-of-sight.

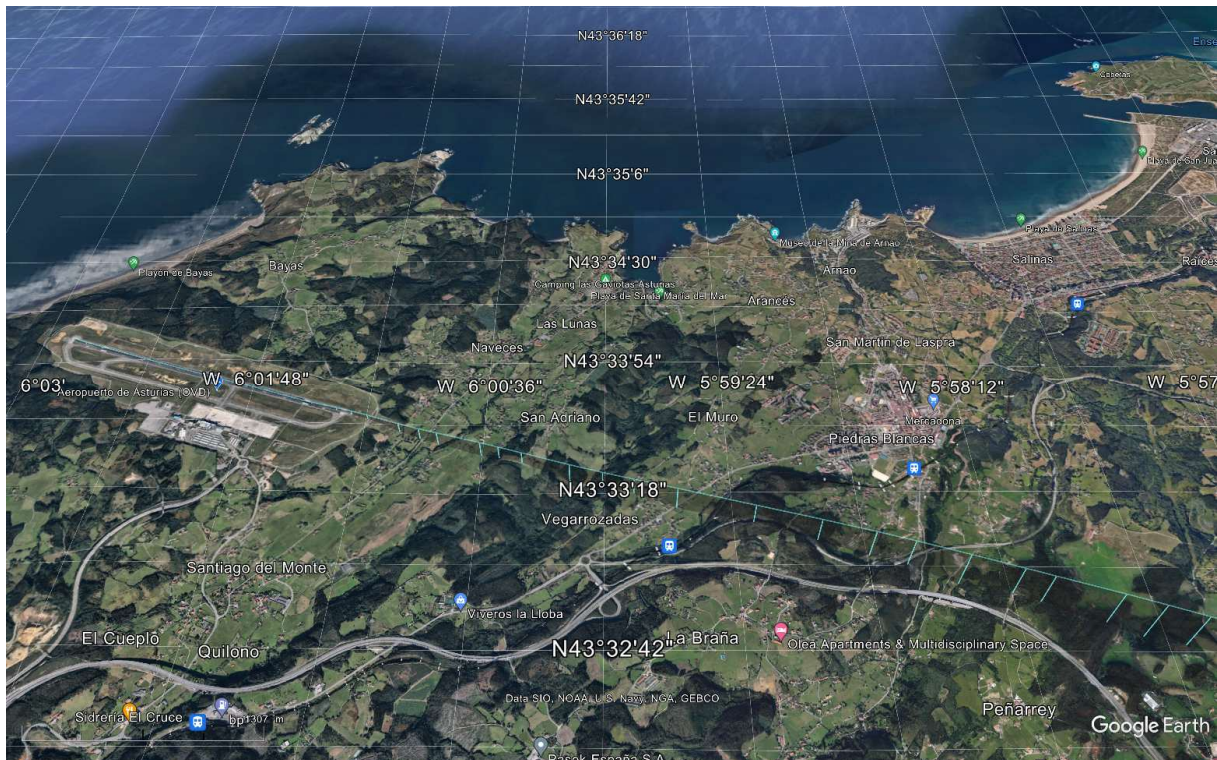
Figure 4: Recorded approach track

The recorded GP data showed that the aircraft was crossing the threshold rather high, but with the glidepath signal being consistent with the reference position.

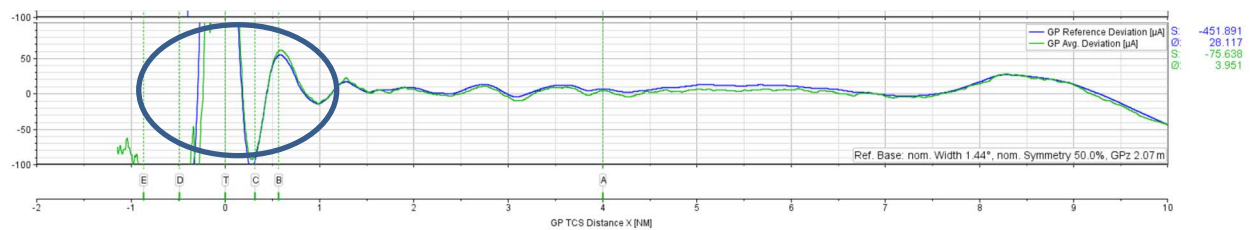
Figure 5: GP measured and reference deviations

However, the aircraft performed a climb to +500µA at threshold followed by a step descend. Why?

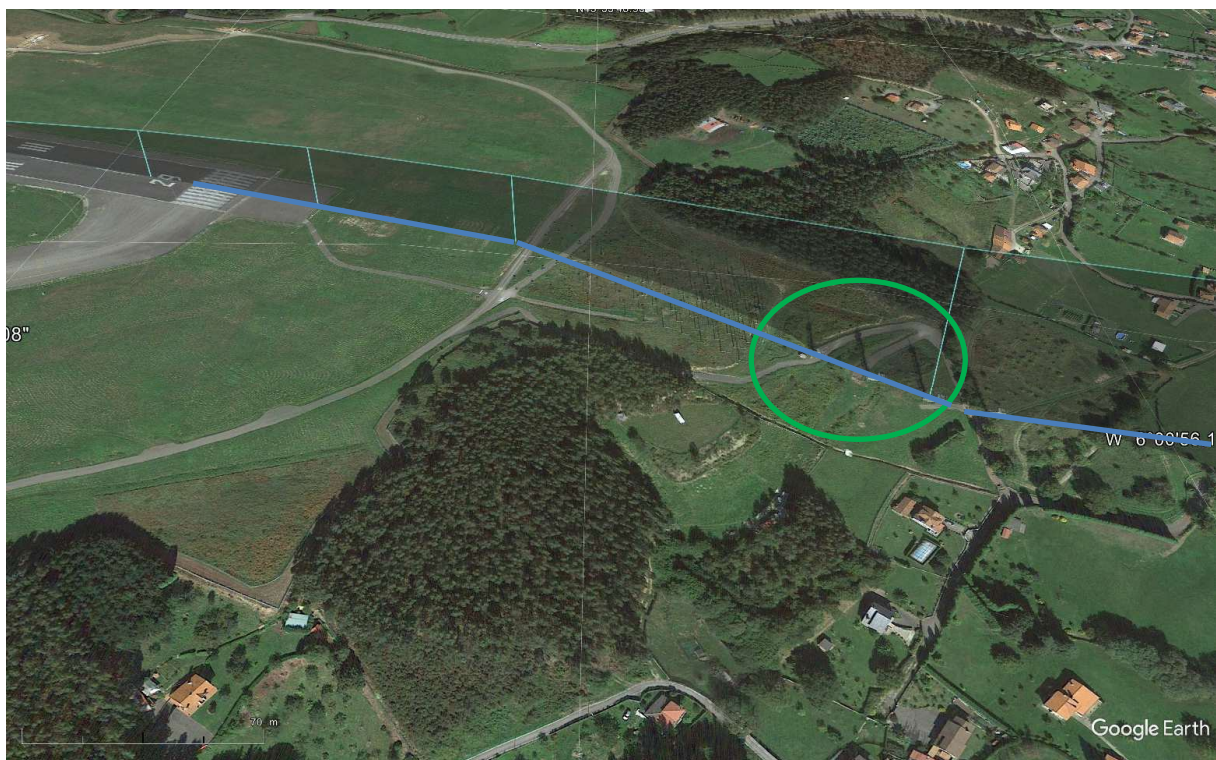
**Figure 7: Terrain gradient change (blue) and installed radar reflectors (green)**

The terrain profile, as obtained by Reference Altitude minus Radio Altitude, shows a series of waves perpendicular to the approach and a steep terrain gradient immediately before the threshold. Google earth shows a road of serpentine style consistent to the changing terrain gradient. There were radar reflectors installed, but the radio altitude was only mildly impacted. So, the irregular terrain shape (see [3]) was not fully mitigated by the installed reflectors. The problem cannot be new, as the reflectors are already present also on much older Google Earth pictures.

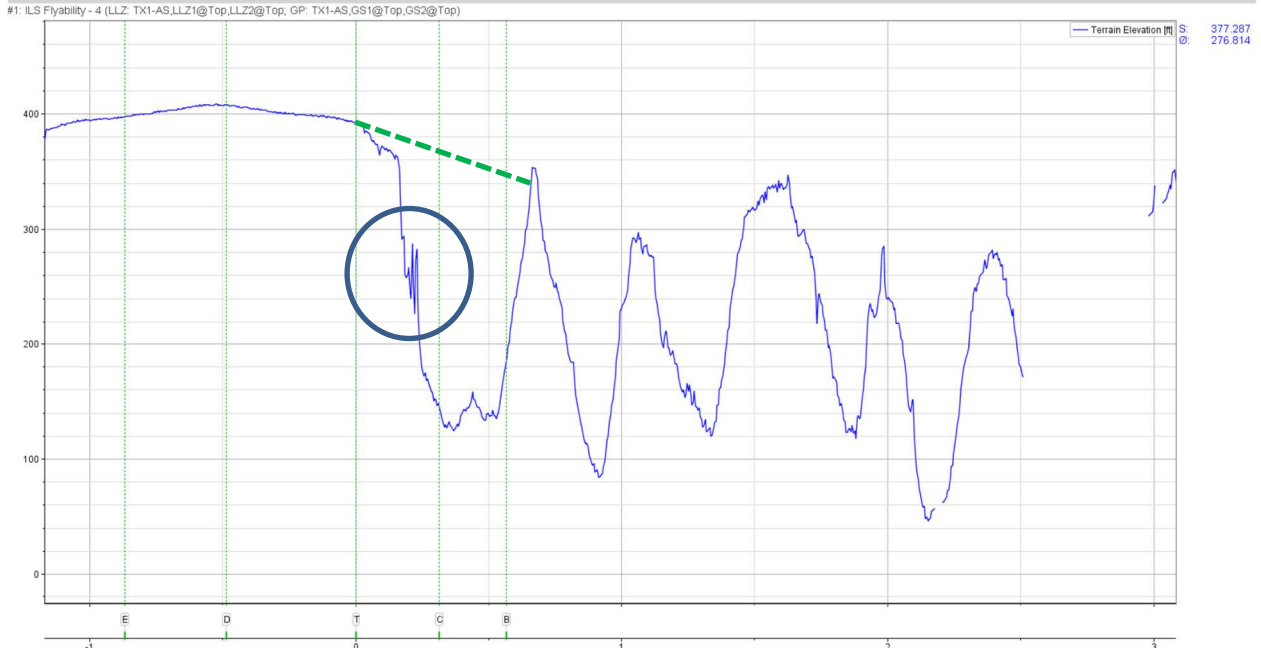
**Figure 8: Terrain and Radio Reflectors**

The Radio Altimeter, which plays a significant role in the last approach section before touchdown, does not get the green dashed signal, but the blue one which indicates the ground comes closer rather quickly. Very likely, this causes the aircraft to fly up and immediately later, plunge down. The sequence of five (!) equidistant perpendicular valleys may even match the frequency of the autopilot control loop leading to a resonance effect.

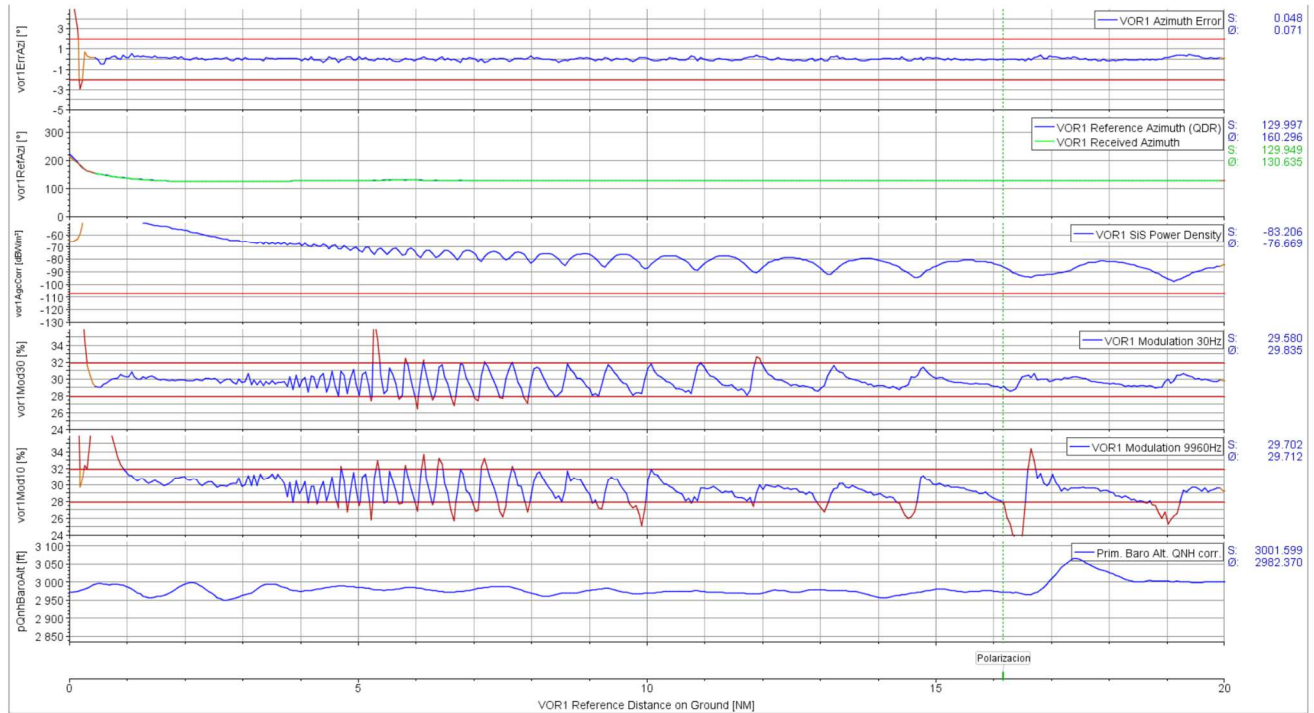
**Figure 9: VOR radial showing typical multipath pattern**

There was a customer's request to explain different signal-in-space (SiS) results at a VOR radial when using top and tail VOR antenna. The first reason was rather straightforward. The VOR SiS graph shows typical "bouncing" effects when flying over water, which was the case, as Google Earth revealed.

The signal shows typical multipath, exactly as in simulation.

The recommendation was to either relocate the VOR or install antenna modifications to reduce the multipath.

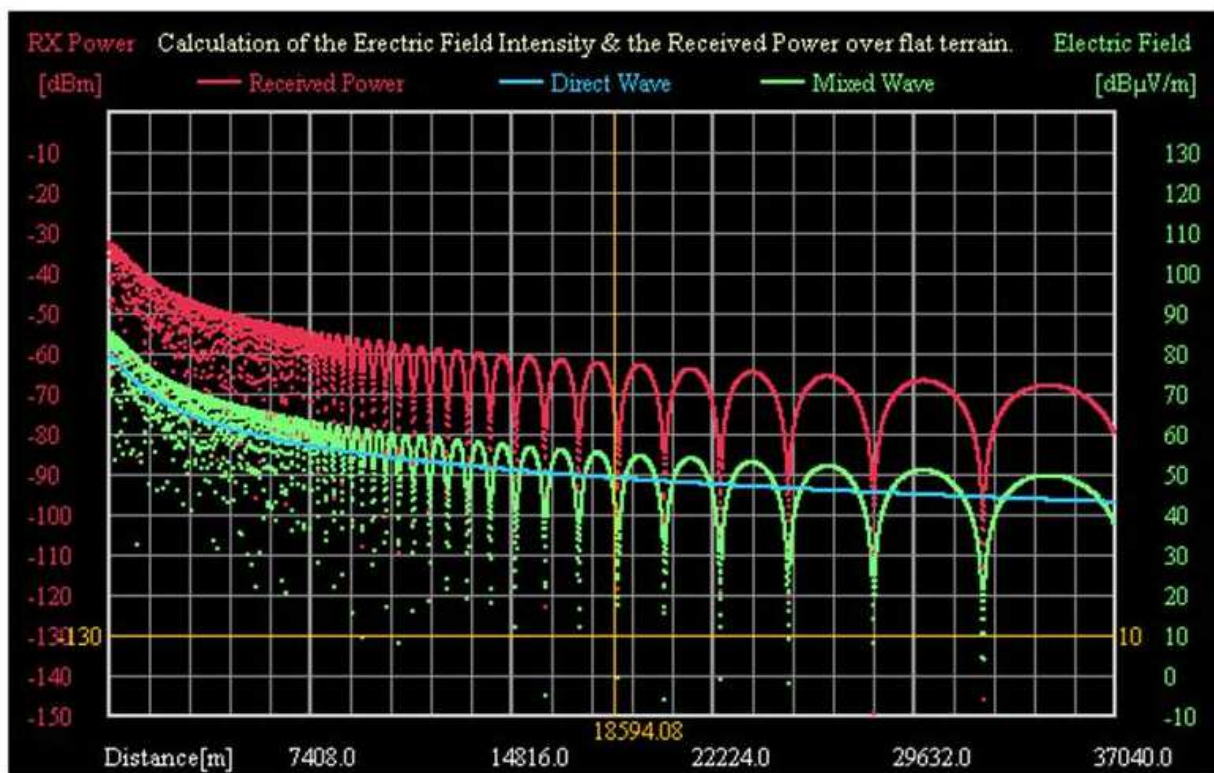
Figure 11: Numerical SiS Simulation using the given VOR geometry

Simulation and real data nicely matched proving that the effect was related to the facility geometry.

Dependent on the location at the aircraft, top and tail antenna show different amounts of multipath, because the reception situation is beyond specification and the field changes rapidly with location.

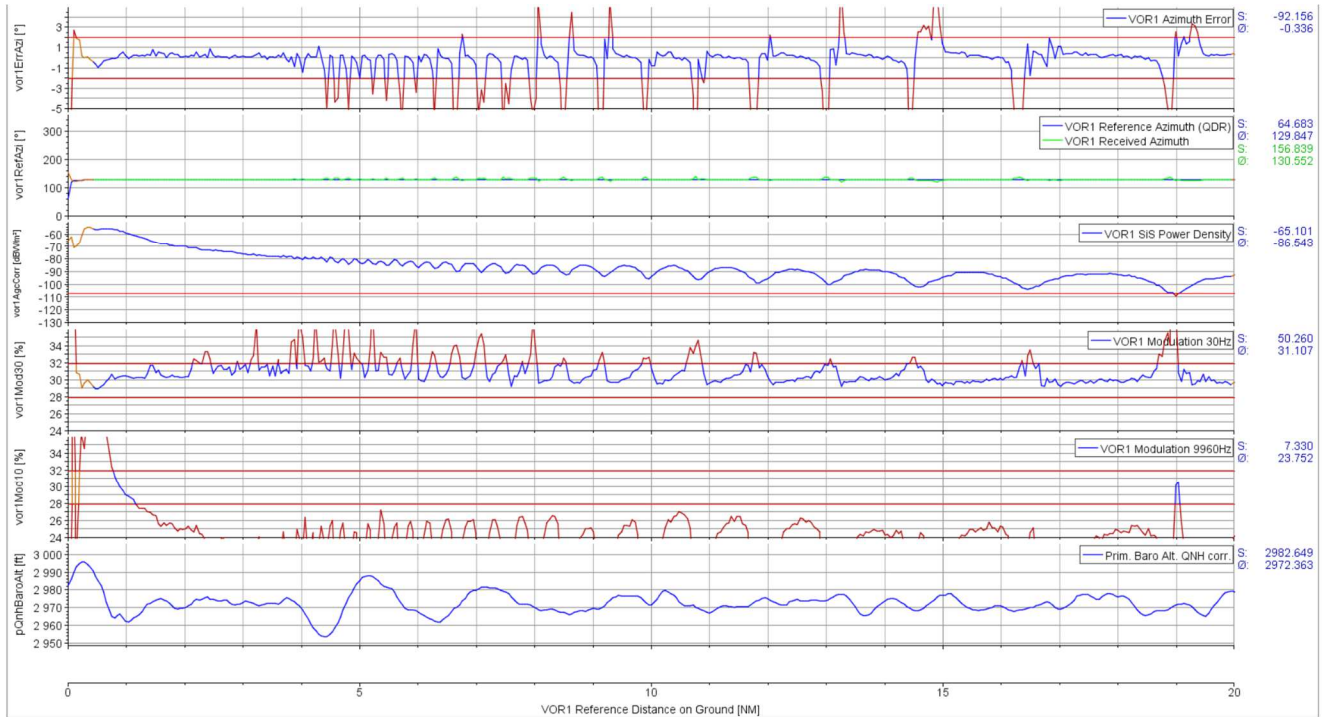
Figure 12: VOR radial with glitches and low 9960 modulation

On the same flight, which already showed the “bouncing” SiS indicating multipath as in the training books, a second, independent effect appeared: On some profiles, the 9960 Hz modulation was significantly weak, the 30 Hz modulation and the azimuth error had strange peaks going out of tolerance (Figure 12, Figure 13). This happened at the top antenna only. The crosscheck using the tail antenna was good and the effect was independent of the receiver.

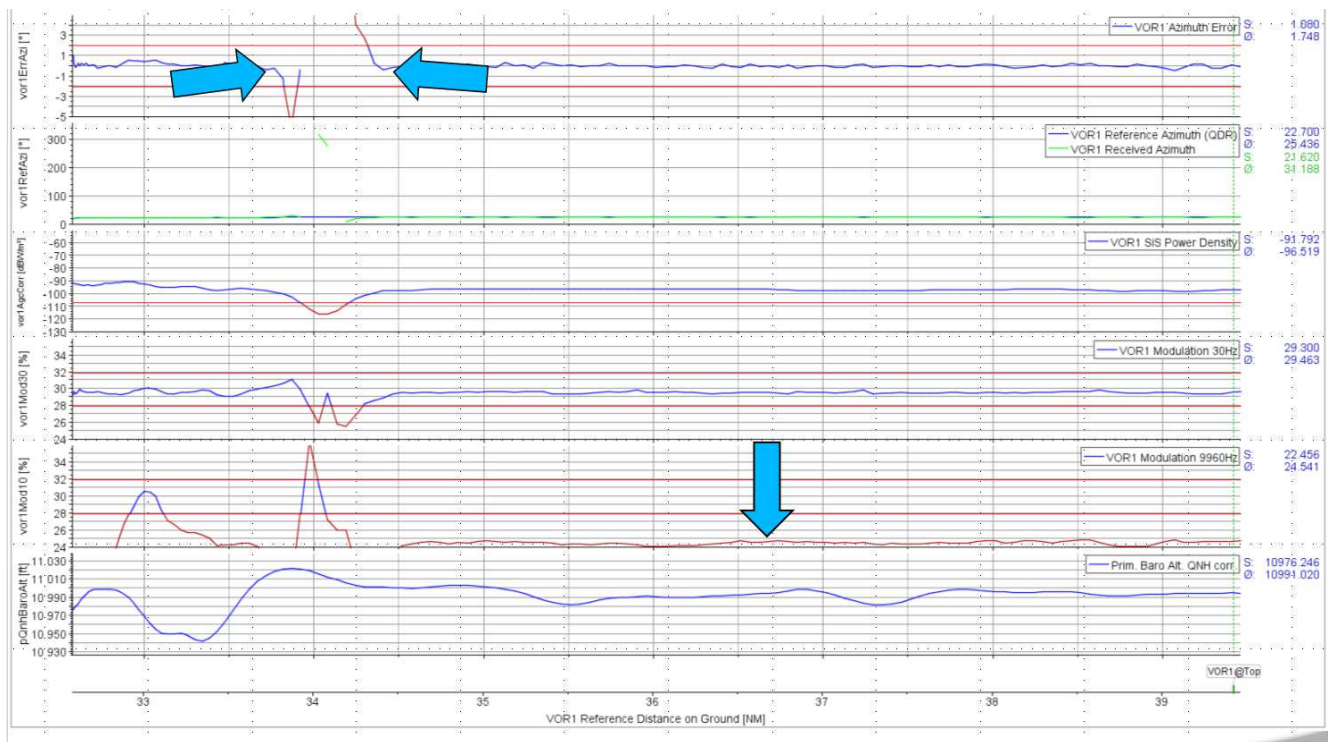
Figure 13: Zoom of a single glitch

This gives a strong indication that the antenna is the root cause. But how can it impact the 9960 Hz modulation despite the SiS being fine? The spectrum analyzer allows a deeper look into the antenna characteristic by visualizing the VOR video.

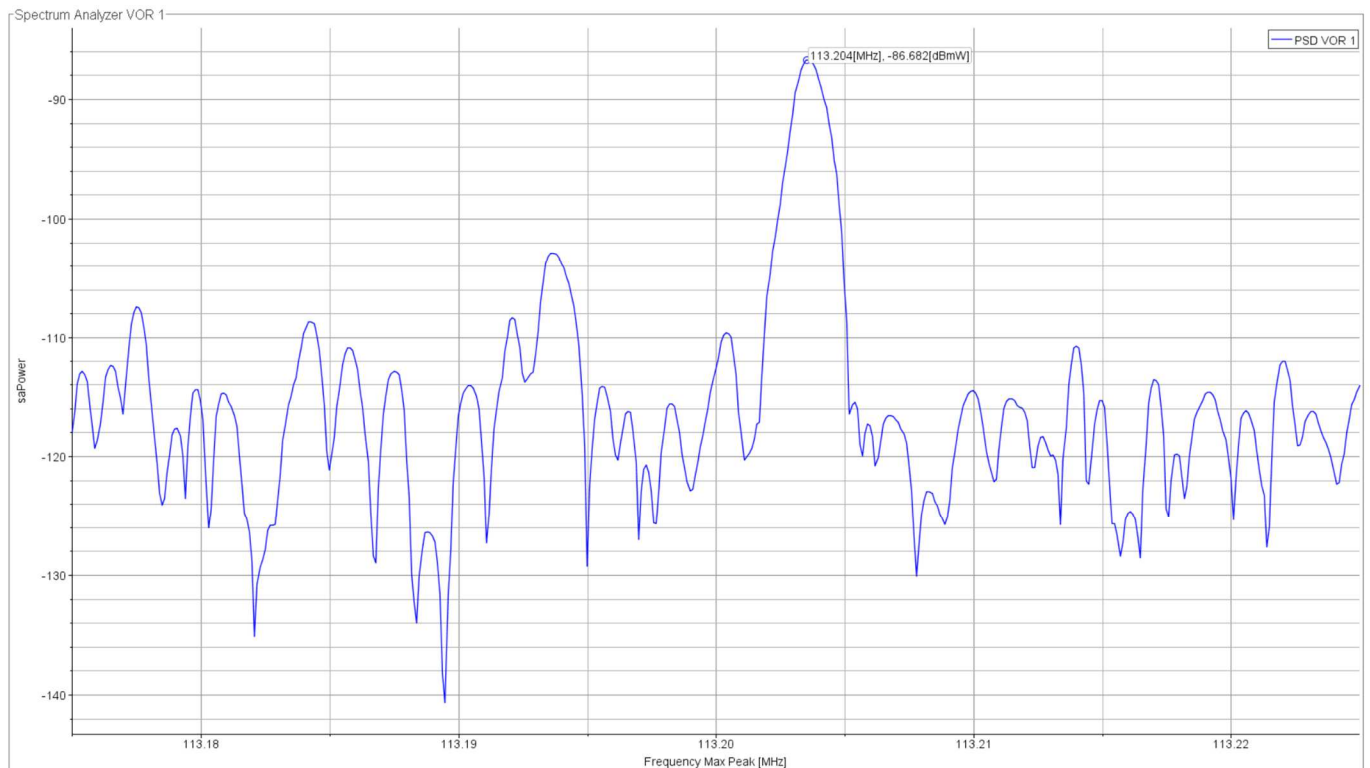
**Figure 14: Spectrum analyzer plot of top antenna**

Figure 14 shows a strongly distorted VOR video, obtained from the top antenna. The modulation peaks are almost gone. No wonder, that the receiver cannot identify 9960Hz modulation and a very small value is indicated.

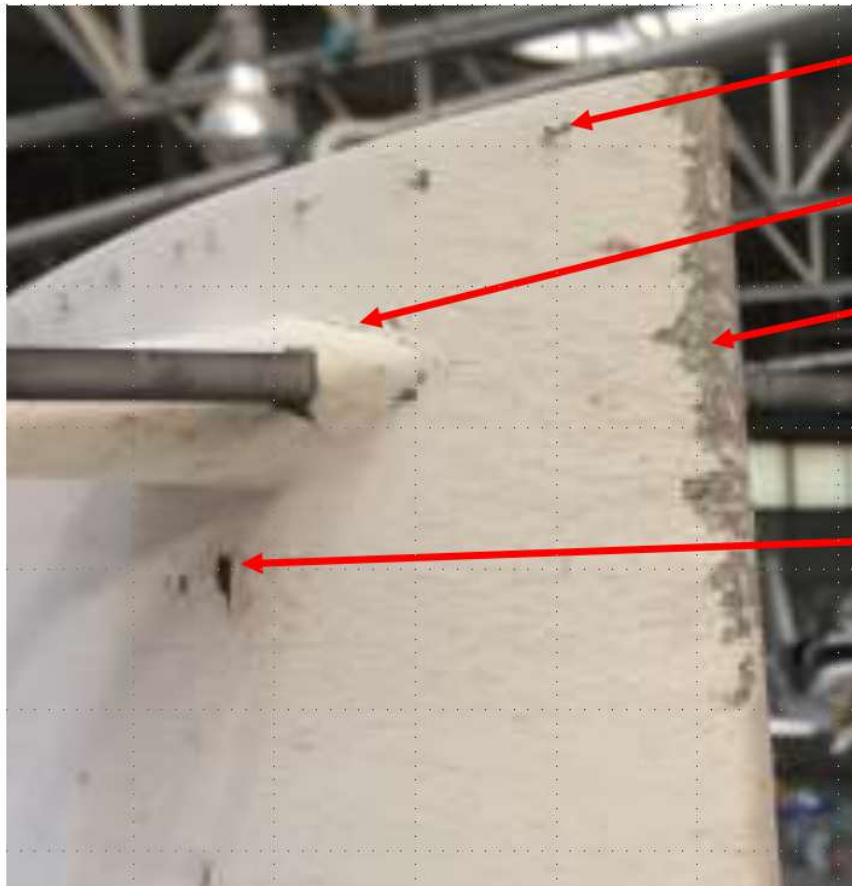
Figure 15: Visual Inspection of the Top Antenna

Rivets

Cracks

Wear and tear  
down to raw  
glass fibre, no  
paint anymore

Paint gone

Figure 15 indicates a poor mechanical status of the top antenna and already indicates a due exchange.

The antenna was exchanged. It was recommended to revise the maintenance plan to include the FI antennas.

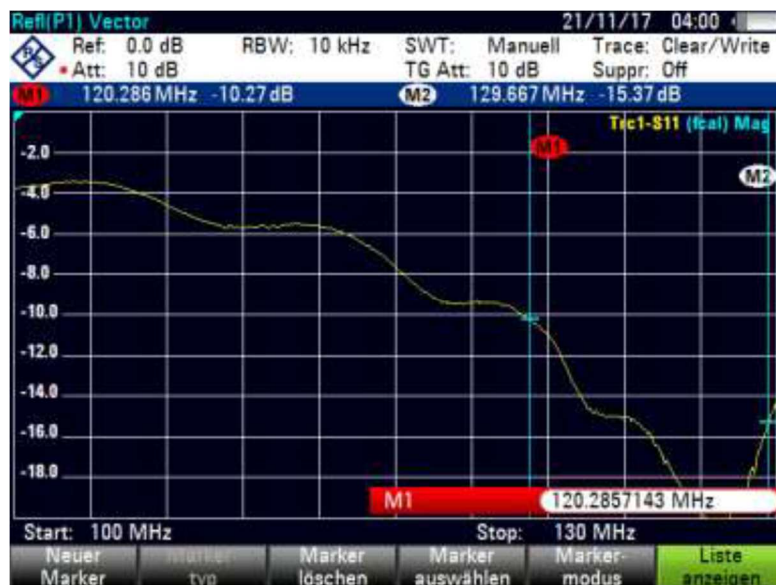
Figure 16: VSWR plot of top antenna

This antenna had a center frequency outside the NAV band, at about 128 MHz.  
The reflection, shown in "dB" unit, is far outside the standards over the full NAV band.

This explains weak AGC and modulation, but there is even more ...

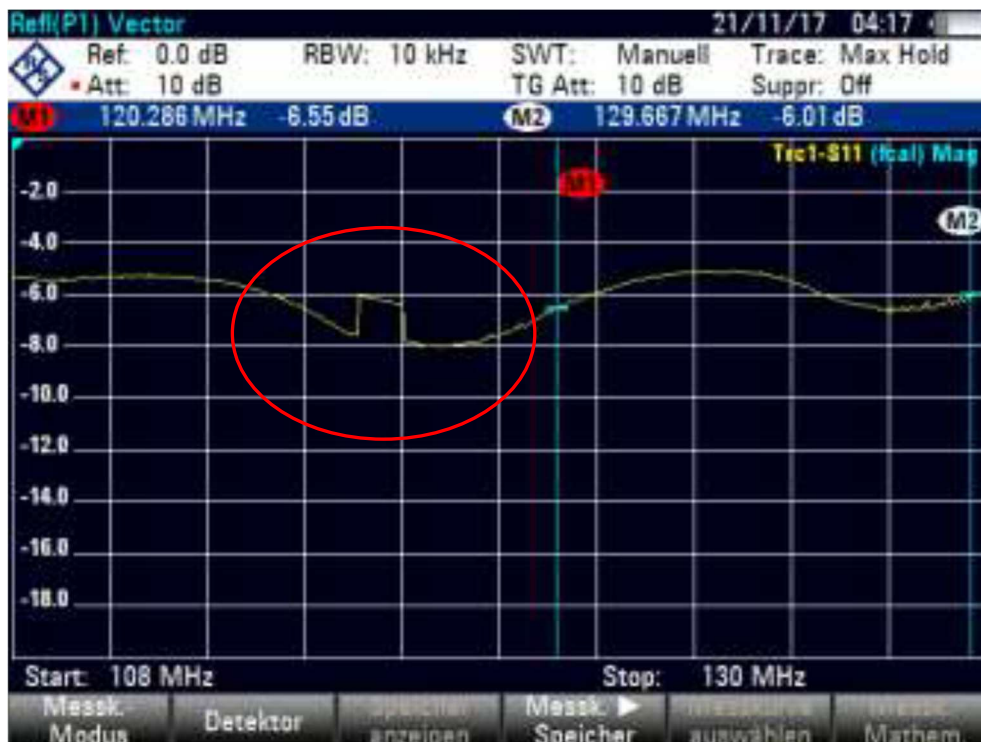
## Figure 18: Glitch proving intermittent electrical disconnection

While the manually forced vibration the reflection plot was monitored, and as short-time spikes showed up, a mechanical intermittent contact was identified.

- The FI console was under regular maintenance
- The aircraft was under regular maintenance
- The FI antennas were not checked at all for 10 years.
- Maintenance responsibility for FI antennas was not clearly defined.
