Traps and Pitfalls 2026 Edition

ABSTRACT

During flight inspection (FI) missions, surprising or unexpected results may appear. A typical situation for this might happen during the commissioning of a brand new, accurate FI System. Its results are compared to those of a well known, but ageing system, which had been approved and even certified decades ago. The typical consequence is to blame the new system, because the legacy one had been accepted and therefore is assumed to be correct.

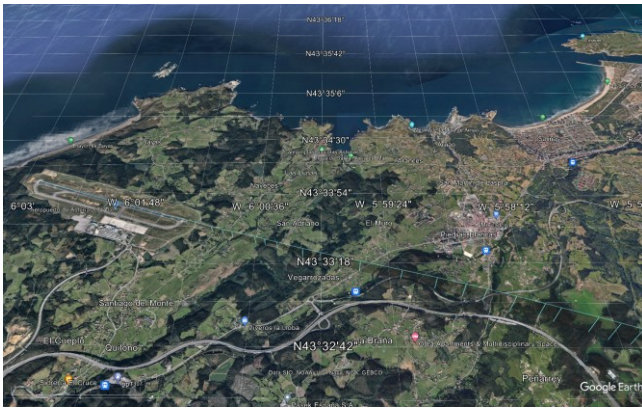
Figure 1: Recorded Approach During Flight Inspection

The recorded data from the specific flight inspection (as displayed in Figure 1) showed a rather high threshold crossing height (TCH), but with corresponding glide path deviations (as visible in Figure 2). Consequently, the glide path error was perfectly within the limits.

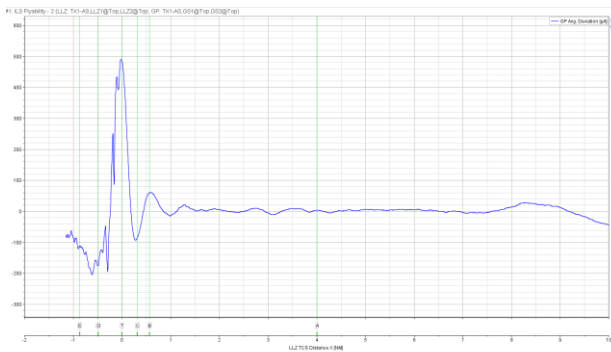
Figure 3: Peak in Vertical Flight Path Before Landing

Figure 3 shows the glideslope deviation over the approach. The glideslope was intercepted at approximately 8 NM out and was stable until approximately 1 NM before the threshold. At that time, the aircraft started to fluctuate around the glideslope signal significantly, crossing the threshold too high before touching down with a higher-than-normal vertical speed. This aligns well with the reported hard landings.

The main cause of this confusion was the dominant source of vertical guidance information. While the glide path signal of the ILS receiver is used for most of the approach, the radar altimeter becomes the dominant vertical guidance source close to the threshold. Accordingly, the recorded output of the radio altimeter was analyzed. Figure 4 shows the difference between the pressure altitude and the radar altimeter measurements, so effectively the measured terrain elevation underneath the approach path.

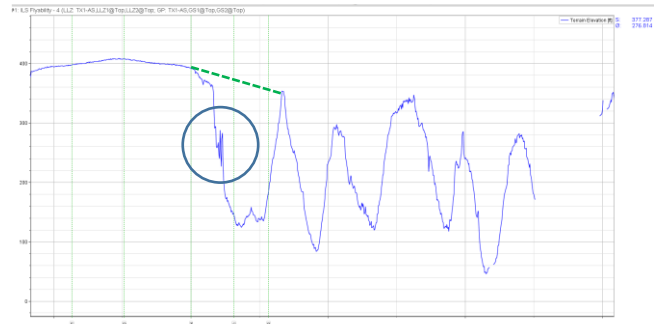
Figure 4: Terrain Elevation Underneath Approach Path

The terrain elevation shows significant valleys between hills shortly before the threshold. In addition, very near to the threshold some signal fluctuations can be observed. By looking at the aerial image in Google Earth (as shown in Figure 5), a rather deep valley with steep elevation gradients (depicted in blue) can be identified easily by the serpentine-style road. In addition, installed radar reflectors can be seen (within the green circle).

Accordingly, the autopilot increasingly uses the radar altimeter readings as it gets closer to the ground, which causes the airplane to oscillate vertically at low altitudes, contributing to the reported hard landings.

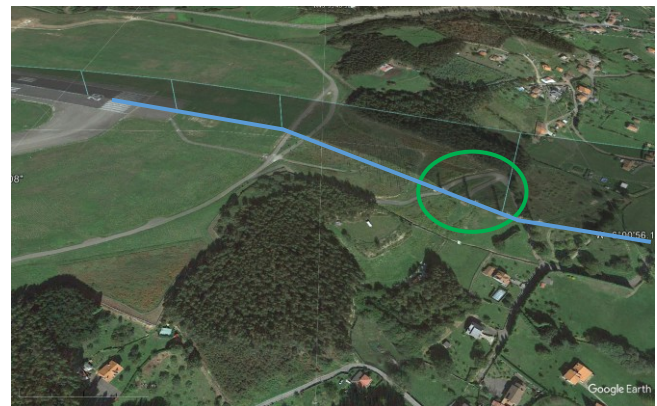
**Figure 5: Aerial Image of Final Approach
Blue: Approximate Terrain Gradients
Green: Installed Radar Reflectors**

As it turned out, the radar reflectors (which, according to older aerial images, had been in place for years) were not overly effective in smoothing the elevation profile for the radar altimeter, which in turn mainly indicated the actual terrain instead.

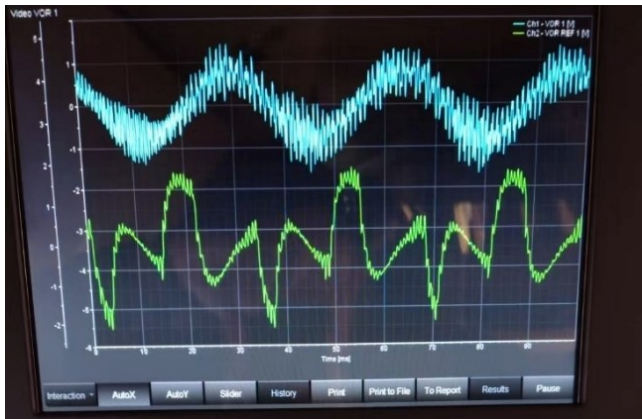
Figure 7: Oscilloscope Screenshot of the Distorted VOR Video Signal

Due to this occurring only at one single VOR station and the two flight inspection receivers on board reporting invalid but differing FMDR values, Aerodata suspected an error within the VOR installation and asked the customer to check the VOR video signal on the oscilloscope, which (as visible in Figure 7) turned out to be significantly distorted.

Based on this, the customer initiated a detailed inspection of the VOR installation, which found an incorrect cable connection within the VOR station. After this was fixed, a new flight inspection was conducted, which confirmed that the observed problem was fixed. The FMDR (as shown in Figure 8) was measured close to the nominal value of 16.0 and the VOR video signal (as shown in Figure 9) no longer showed any distortions.

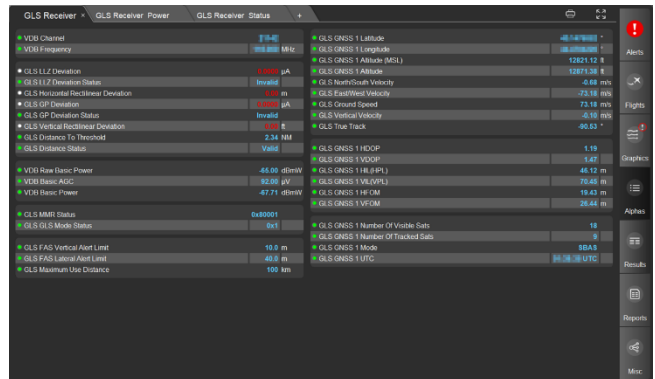
Figure 10: GBAS Deviations Invalid (red)

First, as shown in Figure 10, a replay of the data confirmed that the GBAS receiver did not output any valid GBAS deviations, but had sufficient VDB and GPS (incl. SBAS) reception. The cause for this unexpected behavior could not be found based on the parameters displayed within the software alone, so that a deep analysis of the recorded data was conducted.

The only indication of a problem in this data was eventually found in a status message regarding the authentication service, in which the ‘Differential Correction Magnitude Check’ (DCMC) was found to be failed.

In addition, it is important to note here that such persistent errors flags in the receiver can only be reset by changing the selected approach. Flight inspection operators are advised to change the tuning of the GBAS receiver manually in case of similar observations.

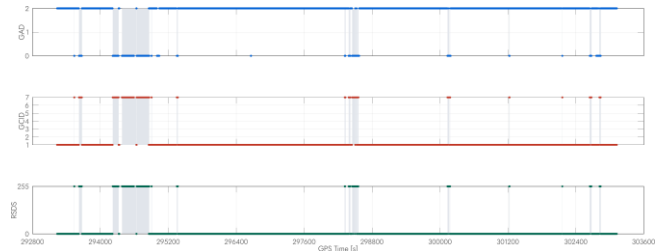
Figure 11: Received MT2 Integrity Parameters

The MT2 VDB messages from the ground station contain different parameters, which are used by the GBAS receiver to ensure overall integrity. The values displayed in Figure 11 show periods with normal operations next to periods with anomalous behavior. This was the first indication that something within the GBAS ground station was not behaving as expected.

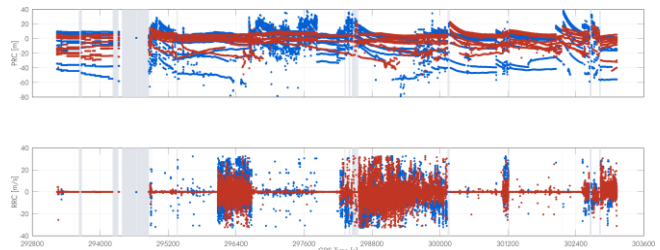
Figure 12: Received MT1 Pseudorange Correction (PRC) and Range-Rate Correction (RRC) Values. (Blue: GPS, Red: GLONASS)

This was confirmed by a deep analysis of the differential corrections being broadcast in the MT1 messages by the ground station. As shown in Figure 12, the differential corrections also showed strong diverging behaviors for different times.

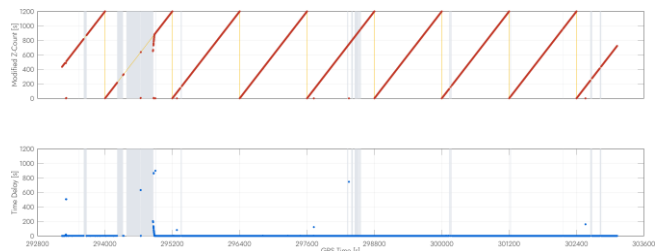
Figure 13: Received MT1 Timing Values

For compensating differences between the time of reception and time of applicability of the differential corrections, the transmitted modified Z-count and the individual range-rate corrections (RRC) are being transmitted within the MT1 messages. The transmitted modified Z-counts and the respective time differences to the time of reception are shown in Figure 13.

Here, the time offset between the applicability of the differential corrections and the reception time exceeds 800 s at one point. For this point, the transmitted range-rate corrections are multiplied with this delay, resulting in excessive differential corrections, which in turn let the DCMC algorithm fail here.

To conclude, both the flight inspector and the GBAS receiver acted correctly here. The overall performance of the GBAS ground facility was not sufficient for regular operation. The GBAS station transmitted invalid VDB data which prevented the modern flight inspection GBAS receiver from outputting its GBAS solution.
