# TRAPS AND PITFALLS RELOADED

## Stefan Jagieniak

## ABSTRACT

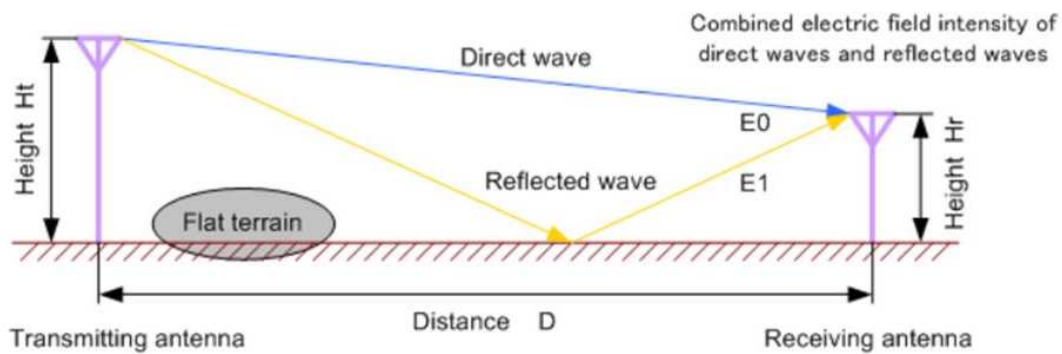
Figure 10: Principle of multipath pattern

Simulation and real data nicely matched proving that the effect was related to the facility geometry.

The VOR was located at some dozen meters elevation at the oceans shore.

The signal shows typical multipath, exactly as in simulation.

Dependent on the location at the aircraft, top and tail antenna show different amounts of multipath, because the reception situation is beyond specification and the field changes rapidly with location.

The recommendation was to either relocate the VOR or install antenna modifications to reduce the multipath.

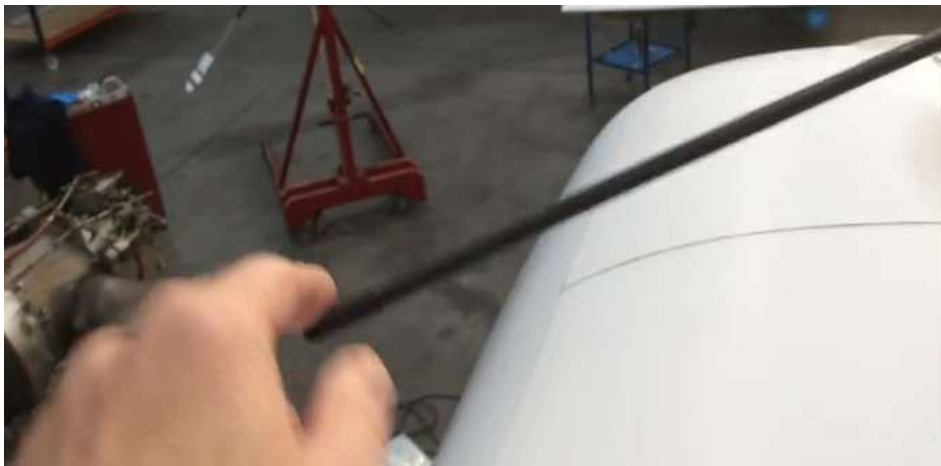
While the manually forced vibration the reflection plot was monitored, and as short-time spikes showed up, a mechanical intermittent contact was identified.

Crack sound was also on the audio. Funny enough, the GP signal was still fine.

Figure 17: Magic Finger performing mechanical Test

The antenna was exchanged. It was recommended to revise the maintenance plan to include the FI antennas.
